Broken Headlight Replacement on a 2018 Axis

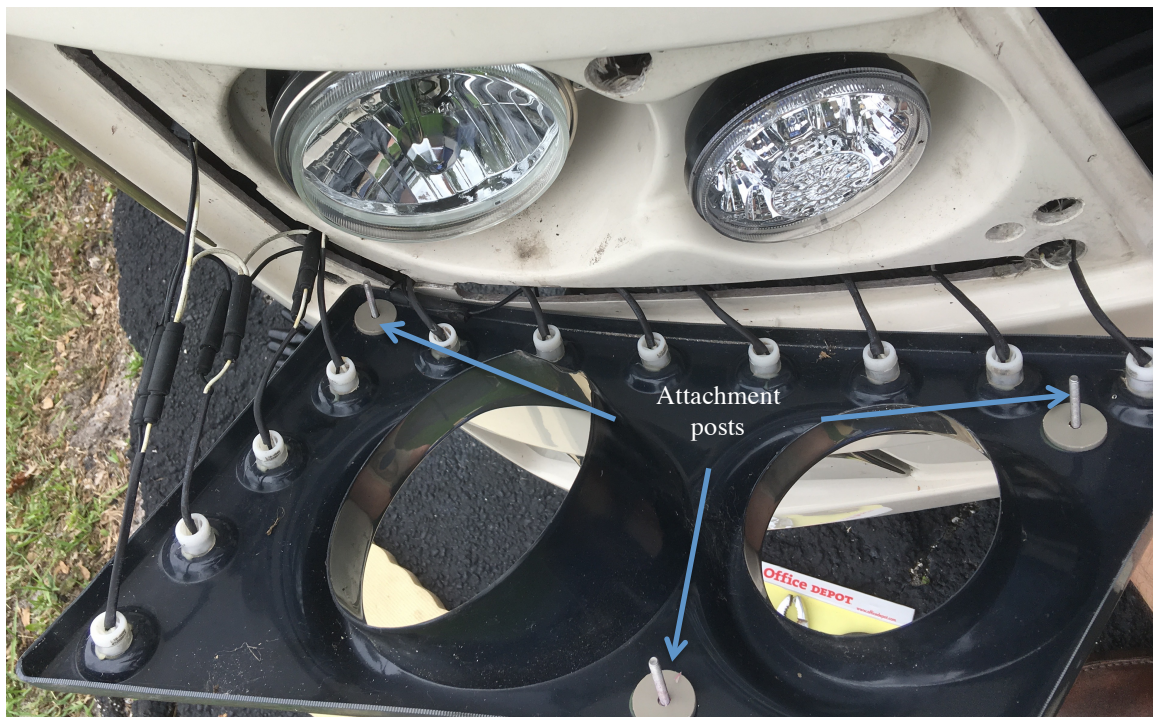
The headlight has VOR DOT SAE HR 01 HB5 NS-2214S molded into the lens, but appears to be the same Kaper II L01-0035 Clear 5 3/4" Headlight used on previous models. I paid \$20.70 plus \$1.45 tax and it was shipped for free with Amazon Prime to my mailbox in two days. (The dealer quoted \$107 for the part plus ~\$100+ for labor and could get to it in a month or two.) I was very happy to spend 20 minutes of my time replacing it and avoid a 100 mile round trip to the shop.

Remove the three Nyloc nuts and fender washers from the attachment posts on the back of the chrome plated plastic bezel surrounding the headlight and turn signal. Don't unplug the LED accent lights. Just tilt the assembly forward and down to uncover the stainless holding ring around the headlight. Remove the three screws holding the ring, but not the headlight frame adjusting screws. Slide the headlight out and unlatch/unplug the light bulb connector. Reverse the process to replace.

(Notes: Turning the wheel away from the side being repaired helped access the lower/outboard nut and the other two nuts were easy to reach from under the hood. Refit the LED wires carefully back thru the slots and don't over tighten the nyloc nuts. The turn signal assembly just has two nuts holding it on from the back and doesn't require removing the bezel for replacement. The fog light is an independent assembly.)
