Thor Motor Coach Recall Repair Instructions

Recall # 13V-265/ 2013-217 (Canada)

Description/Title: **RV Custom Product FW-2050 Battery Control Center**

Service Campaign # : **RC000077**

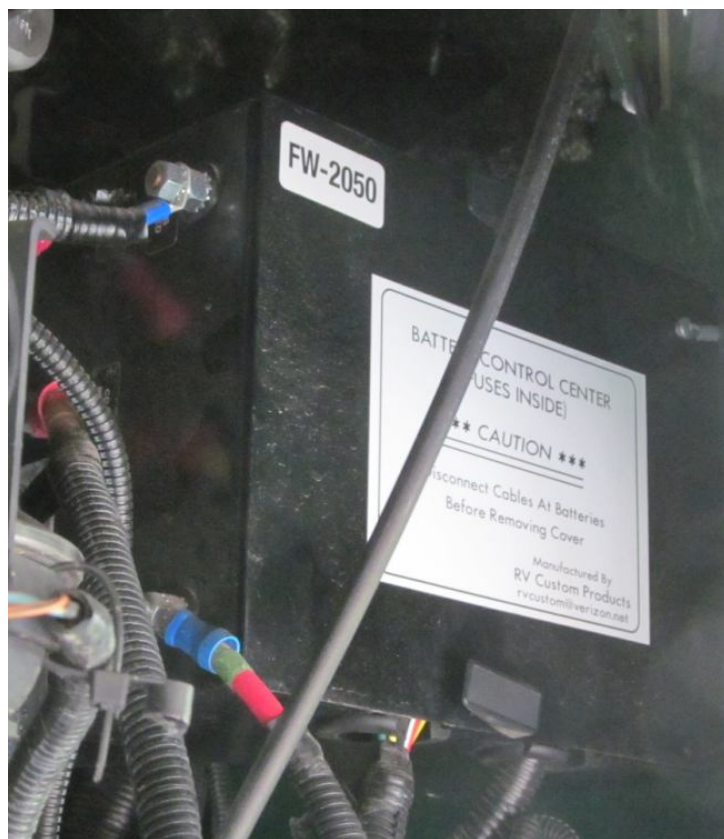
SUMMARY: On certain gas Class A units with the RV Custom Products FW-2050 Battery Control Center (BCC) there may be an issue with the chassis battery disconnect.

1. Locate the FW-2050 Battery Control Center. It should be under the hood, usually on the driver's side.
2. Disconnect the Chassis Battery and Cable at the Battery
3. Verify that the House Battery Disconnect is turned OFF.
4. Verify that the coach is NOT plugged in.
5. Verify that the generator is NOT running.
